FORD:
2009-2010 Escape

MERCURY:
2009-2010 Mariner

TSB 09-22-19 (Continued)

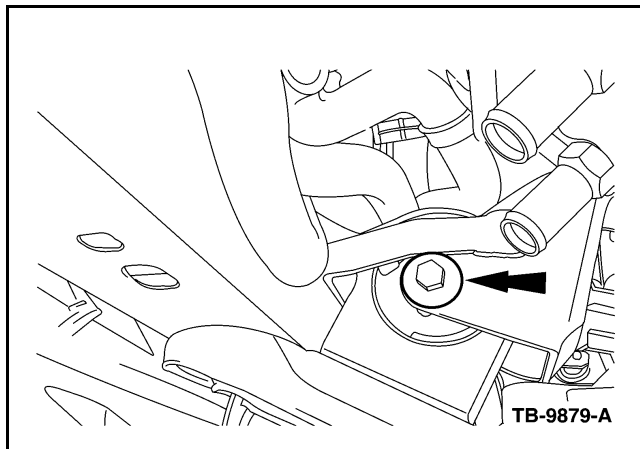
Figure 1 - Article 09-22-19

1. Disable the vehicle high voltage electrical system following Workshop Manual (WSM), Section 414-03 High voltage traction battery systems depowering.
2. Remove the lower transaxle insulator through bolt. (Figure 1)

6. Install the rear roll restrictor-to-crossmember through bolt. Tighten to 66 lb-ft. (90 N•m). (Figure 2)
7. Install the lower transaxle insulator through bolt. Tighten to 85 lb-ft. (115 N•m). (Figure 1)
8. Enable the vehicle high voltage electrical system following WSM, Section 414-03.

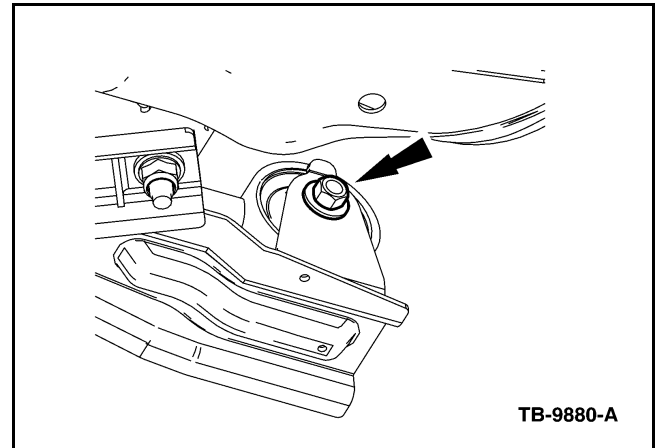
Figure 2 - Article 09-22-19

3. Remove the rear roll restrictor-to-crossmember through bolt. (Figure 2)

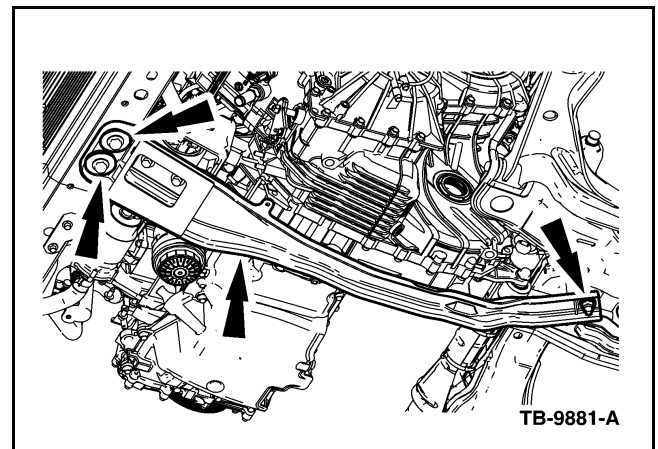
Figure 3 - Article 09-22-19

4. Remove the nut, bolts and engine support crossmember. Discard the nut. (Figure 3)

5. Replace the engine support crossmember with improved service level crossmember. Tighten the bolts to 66 lb-ft. (90 N•m), tighten the new nut to 129 lb-ft. (175 N•m). (Figure 3)
